CONNECTICUT RIVER BASIN LYNDON, VT

INSTITUTE POND DAM VT 00216

PHASE I INSPECTION REPORT NATIONAL DAM INSPECTION PROGRAM

DECEMBER 1980

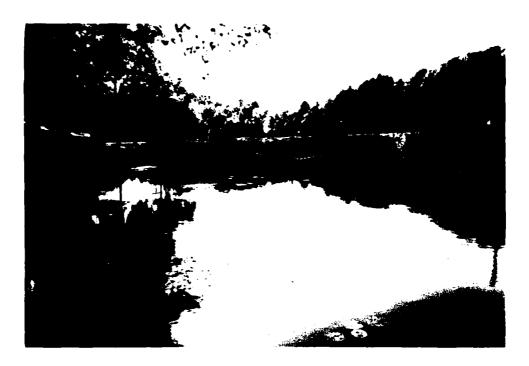
#3 - Road Embankment, State Aid Highway #9, upstream side of road (notice 48 inch culvert)(Photo location on Possible Flood Damage Area Map - Appendix D)

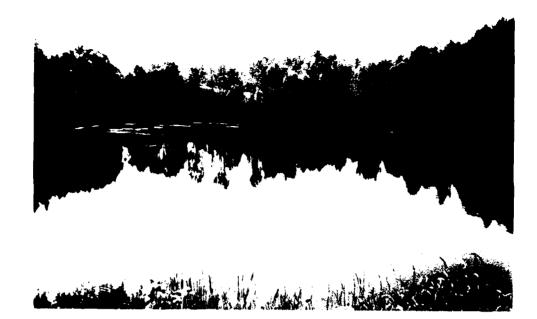
#1 - Crest of Dam, from State Aid Highway #9(notice 48 inch culvert, discharge end, lower left corner) (photo location on Possible Flood Damage Area Map-Appendix D)
